Background

Case performed by Doç. Dr. Ülkün Ünlü Ünsal

CASE STUDY

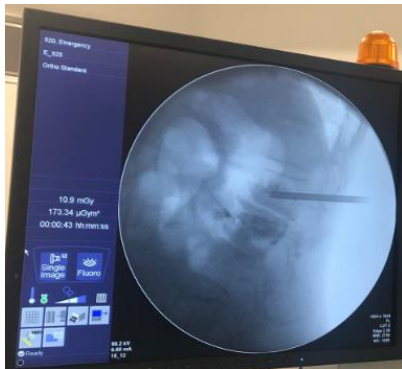
2. Imaging of the defect in the spine at the beginning of the operation.

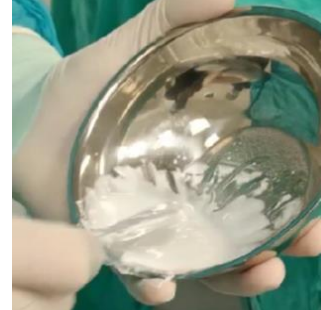
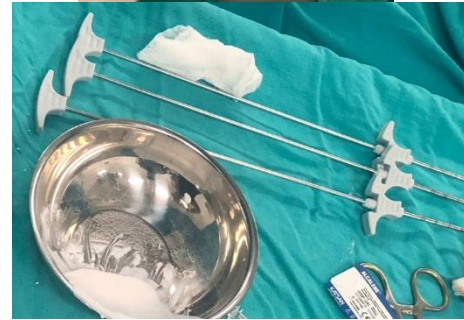
3. The Powerbone Bone Cement LV20 preparation process has been completed and the Bone Cement Applicator Kit, which is a Bone Filler and Pusher Cannulated Screw, has been filled for application.

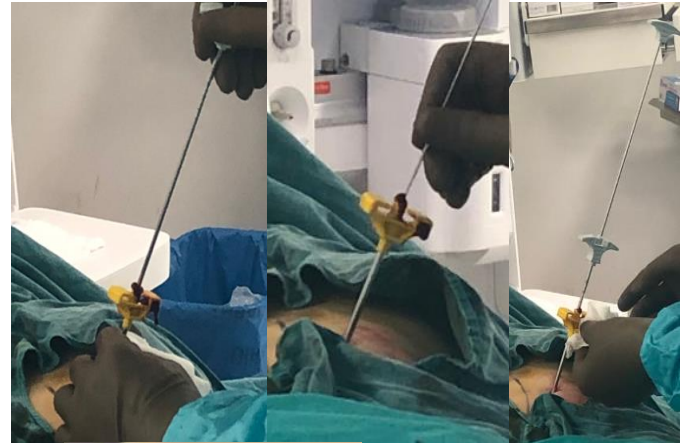
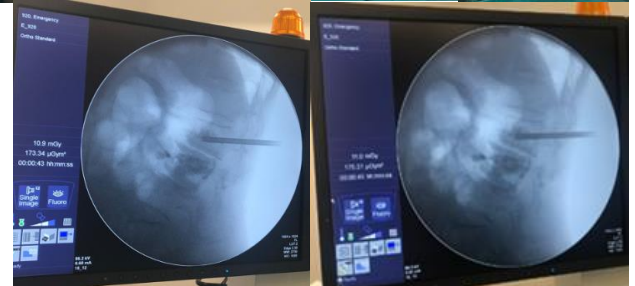
4. Bone Filler and Pusher Cannulated Screw waiting in the prepared state are prepared to be applied to the defect area. With the application of Bone Cement, the change in imaging is observed.
